**Cass Gilbert's  
Westchester Avenue Station**  
Vacant structure of the Former New York New Haven and Hartford Railroad  
**Pre-schematic Conditions Assessment**

January 15, 2025  
Revised February 19, 2025

Prepared by:  
**SLO Architecture**  
**TYLin**  
**Jablonski Building Conservation**

**PRE-SCHEMATIC STRUCTURAL CONDITIONS ASSESSMENT**

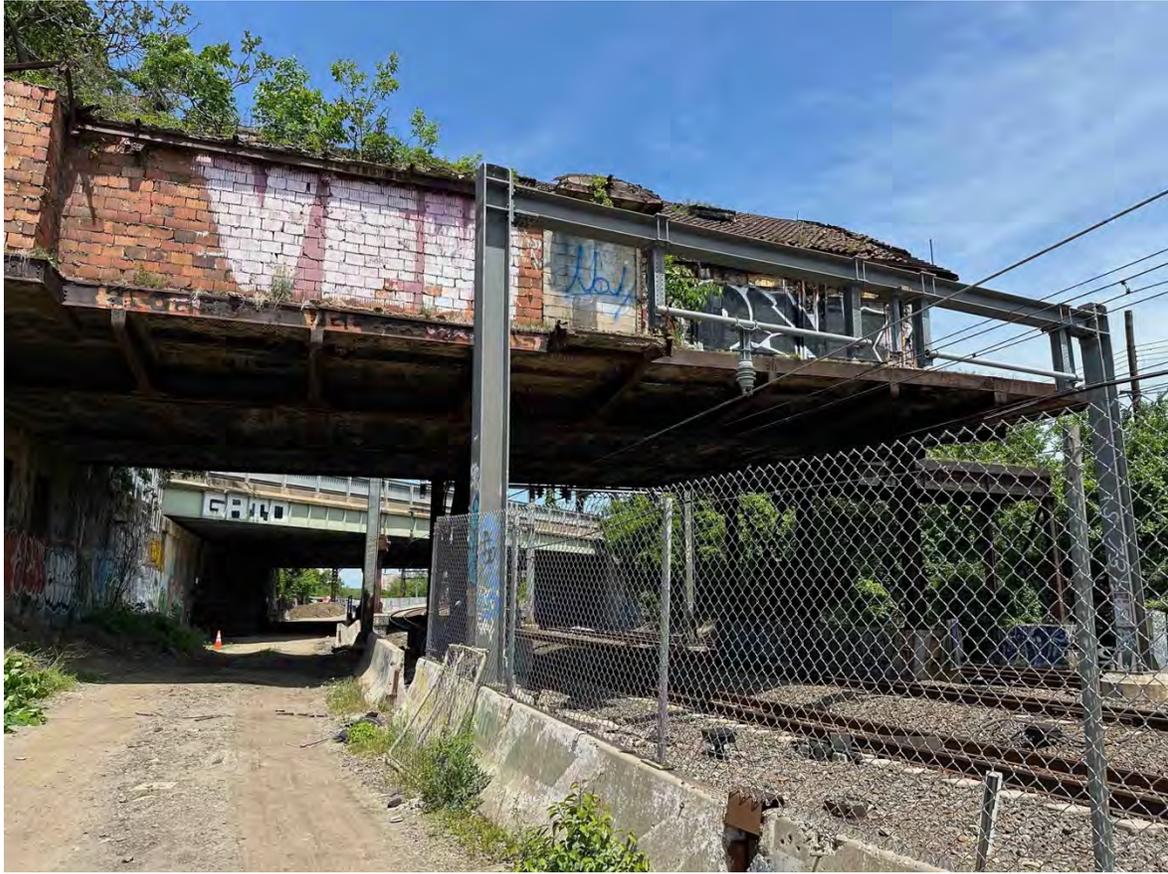
The South Elevation of the station building is principally comprised of a steel frame supporting reinforced concrete floor slabs. The eastern portion of the building (the former waiting room) has been altered many times as part of interim periods of infilling of exterior wall penetrations. The structural deterioration of the exterior walls of this portion of the building is significant and portions of it could fail and fall at any time. As noted in subsequent sections of this report, portions of the roof immediately behind the south exterior wall have collapsed. (See Figure 01, below).

*Figure 01 - Photograph of the eastern end of the South Elevation.*

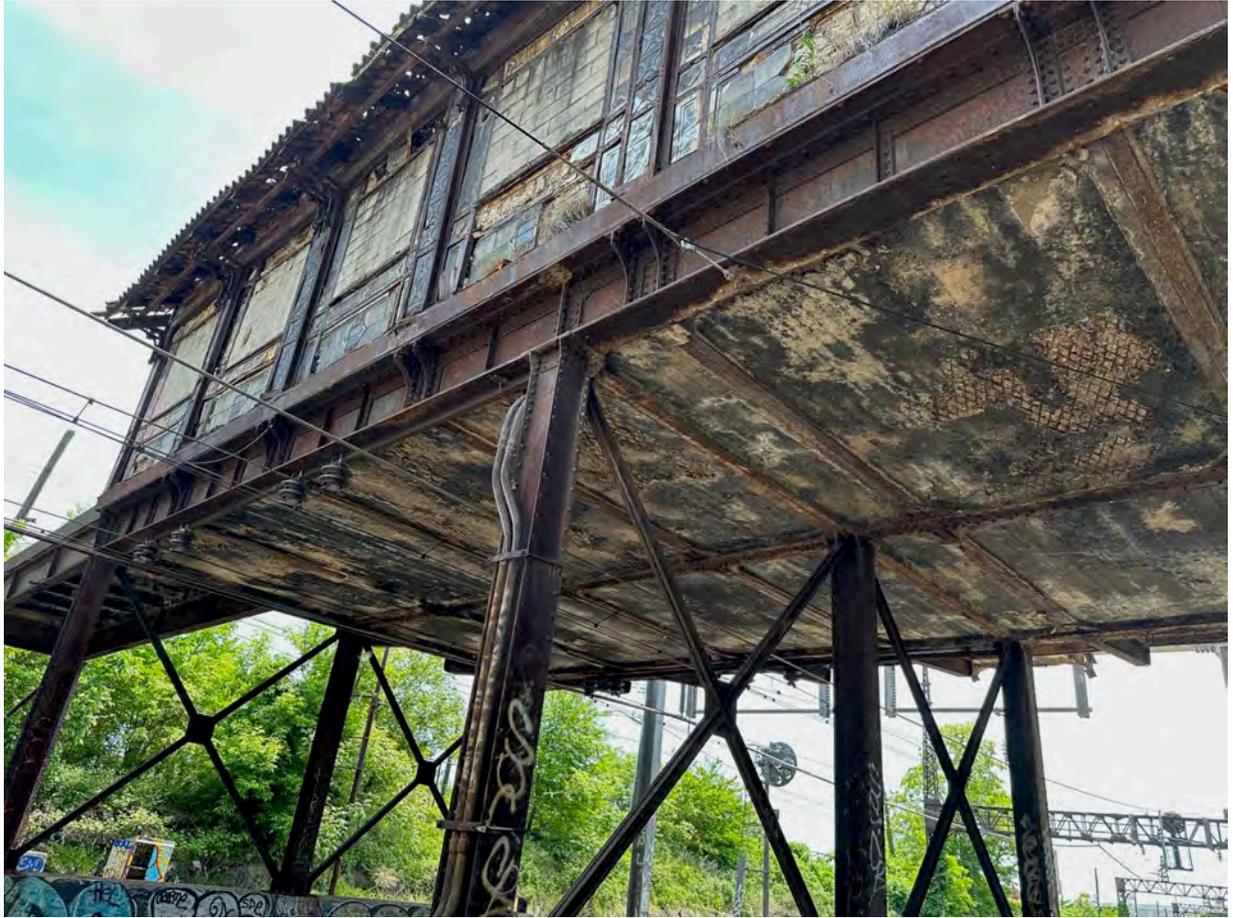
At the east end of the North Elevation the exterior wall is in extremely poor condition and could potentially result in failure of the façade.

The exterior terra cotta and the masonry backup materials are embedded within the rusting steel frame of the building. The terra cotta cladding is held in place in part by these corroding iron elements, by mortar, and by friction. Given these conditions, a failure of the façade (locally or globally) could occur at any time. It is important to note that such a failure is unpredictable. We recommend that this hazardous condition be addressed immediately.

*Figure 02 - Photograph of the underside of the eastern portion of the station showing part of the North Elevation above the train tracks.*

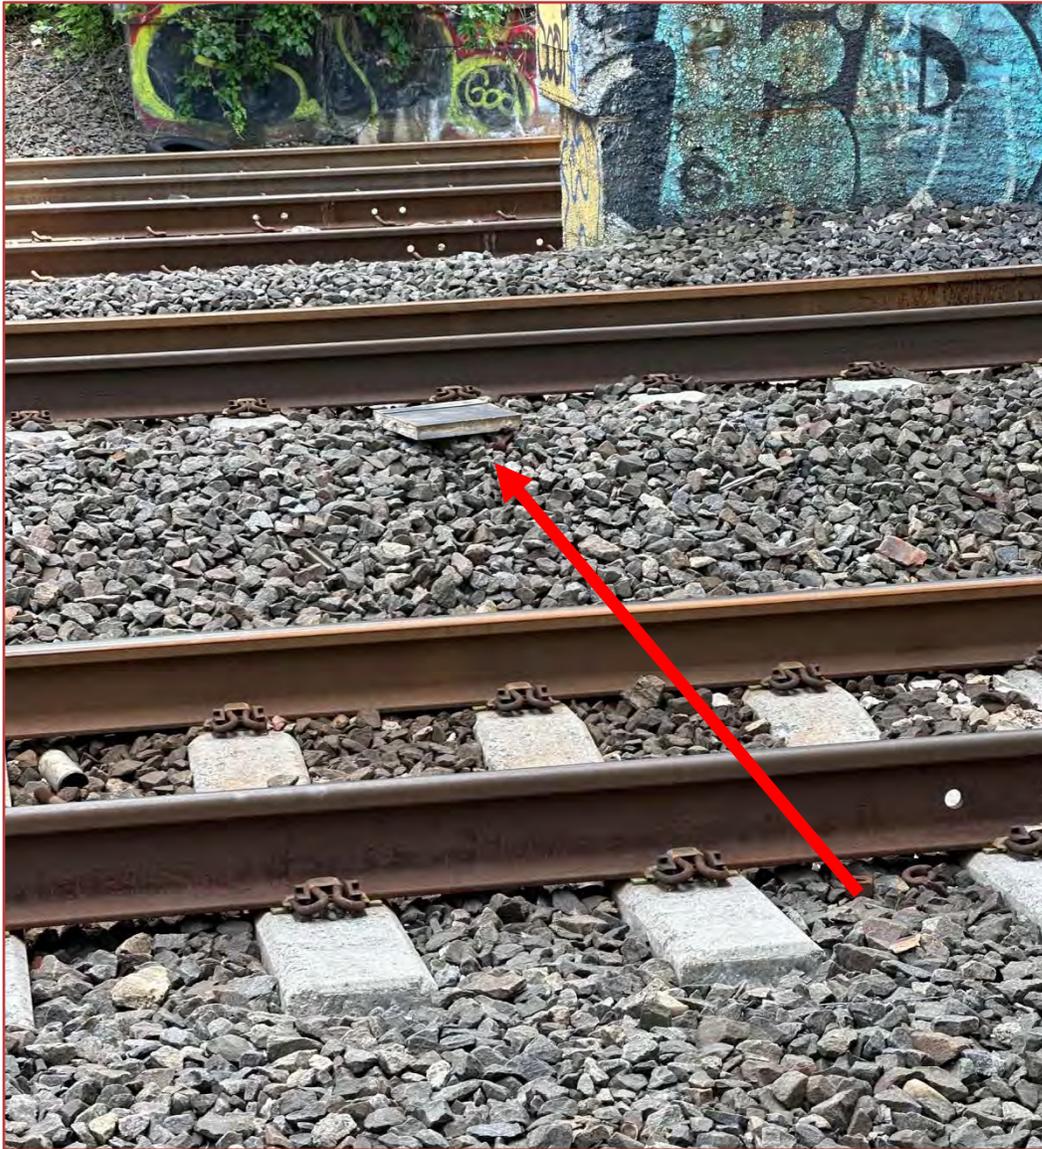
*Figure 03 - Close-up image of one of the pieces of terra cotta that had fallen onto the ballast (below the North Elevation of the station). Note the red arrow points to one of the fallen pieces of terra cotta cladding from the exterior of the Waiting Room portion of the building.*

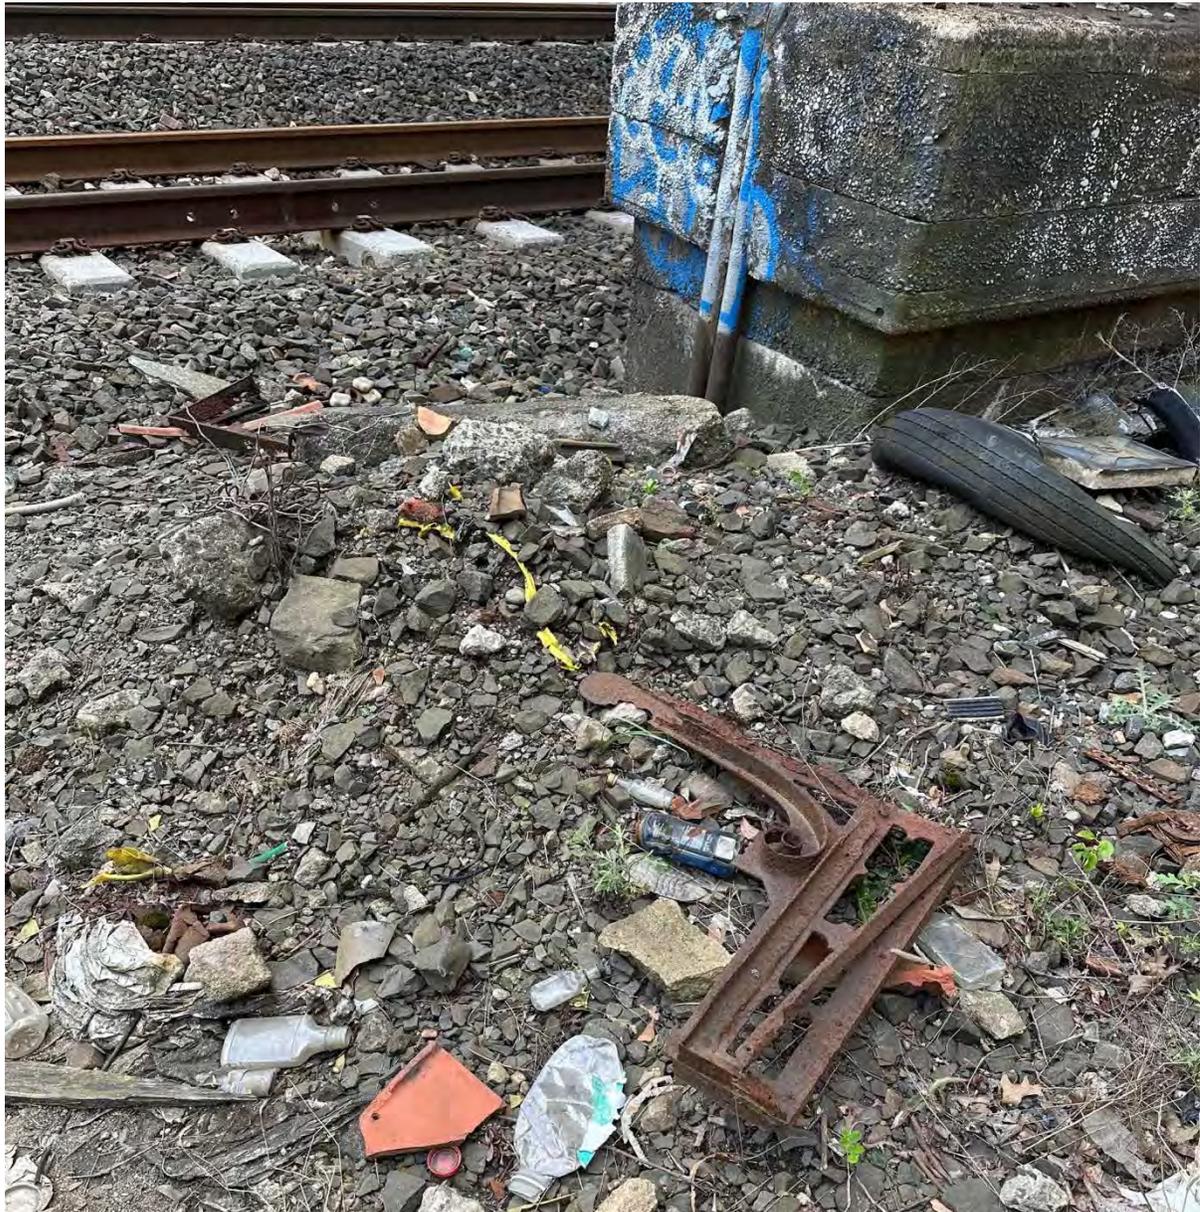
*Figure 04 - Close-up image of one of the iron brackets that had fallen onto the ballast (below the North Elevation of the station).*

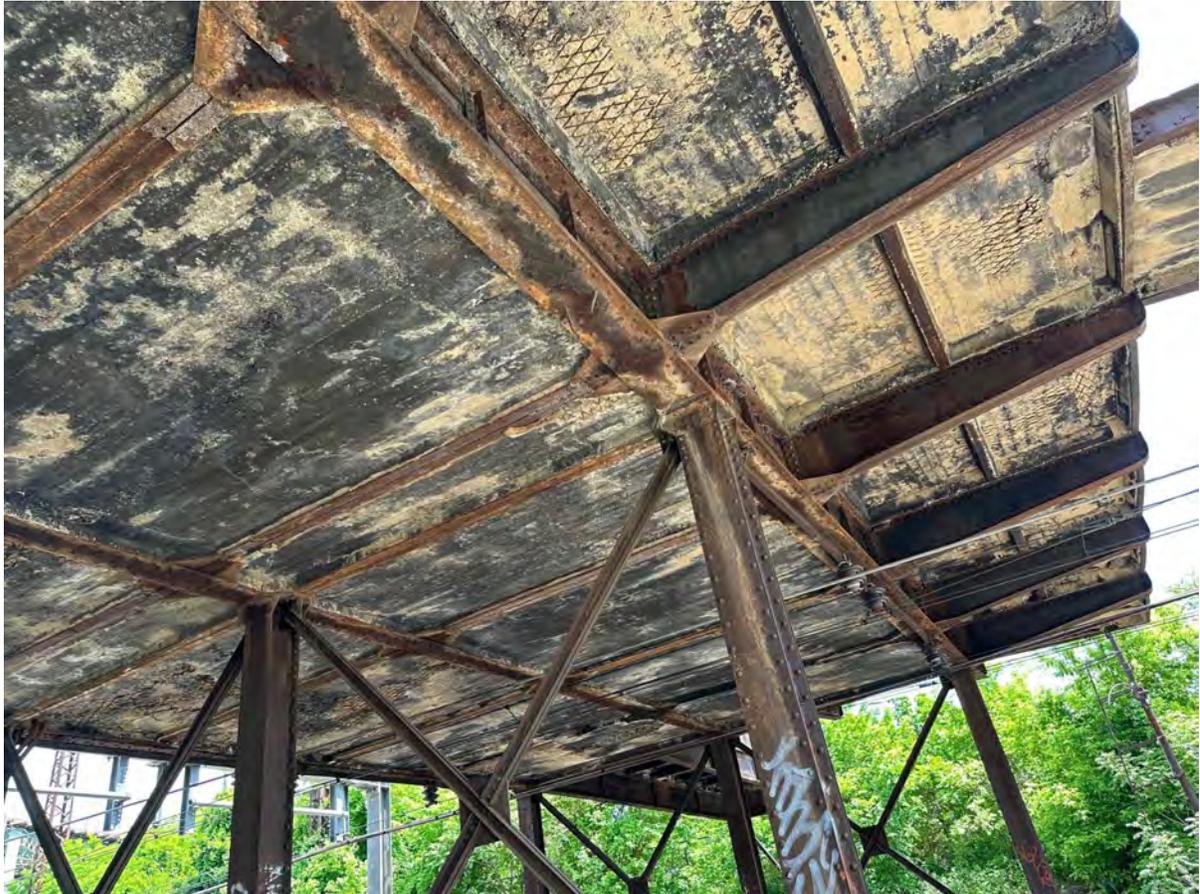
The visibly exposed steel was in fair to good condition and may be a candidate for re-use. The reinforced concrete slabs, however, have significant spalling on their undersides and they represent a potentially hazardous condition. It's worth noting that portions of the concrete slab shown below (in Figure 05) may be a double concrete slab (with a plenum or

*Figure 05 - View of a portion of the underside of the eastern end of the station (above the tracks). This view is looking to the northeast. Note that the exterior surfaces of this soffit appear to consist of a combination of poured in place concrete and a cementitious coating (perhaps a stucco). According to the original drawings, there are two discrete layers of concrete slab forming the main floor system of the waiting room portion of the building.*

The concrete floor slab was in fair condition (with portions of the concrete having already spalled on the underside of the slab). The concrete slab spalling is visible in Figure 05 (above).

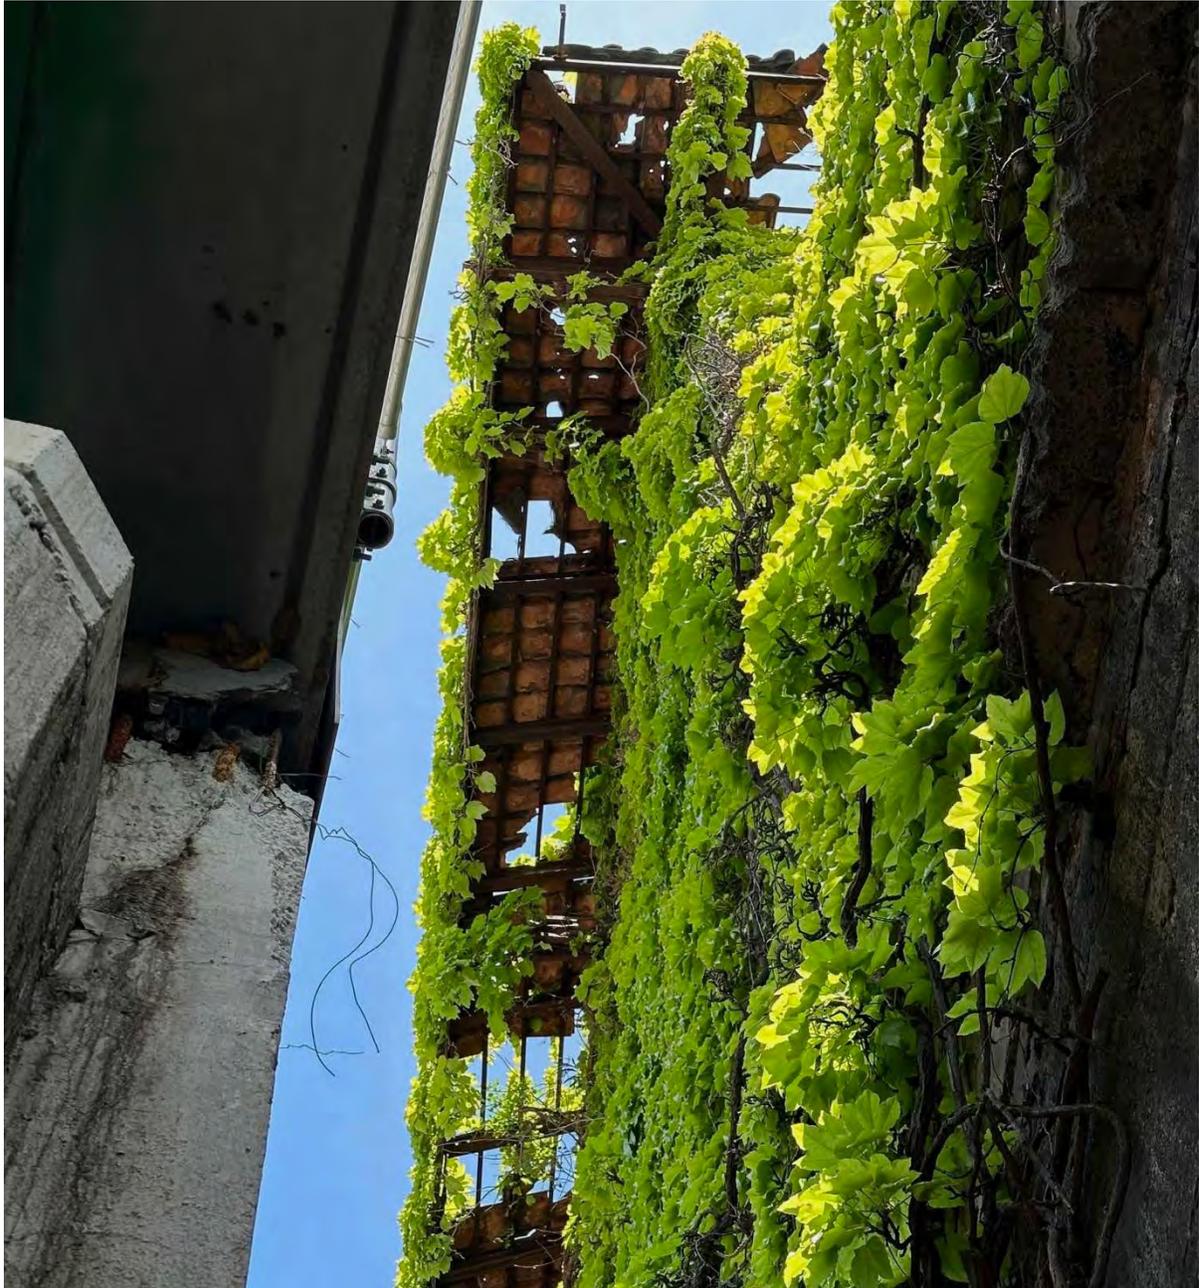
At the West Elevation of the Head House (as with other sides of the building) we noted that significant portions of the roof framing were deteriorated and that portions of the roof had fallen down. This elevation of the building is adjacent to the next door elevated highway and it represents a potentially hazardous condition to those beneath or nearby to the building. See Figure 06 (below) for a view of the underside of this portion of the roof/ eave condition. The roof framing on the south, north, and eastern sides of the Head House all

*Figure 06 - Close-up image of overhanging roof/ eaves on the West Elevation of the station. This is the west wall of the Head House. Note that the steel framing and roofing elements along the perimeter of the Head House have hazardous conditions along their perimeter. The roofing, roof substrate, and portions of the steel framing (at least at the cantilevered edges of the will require removal and reconstruction.*

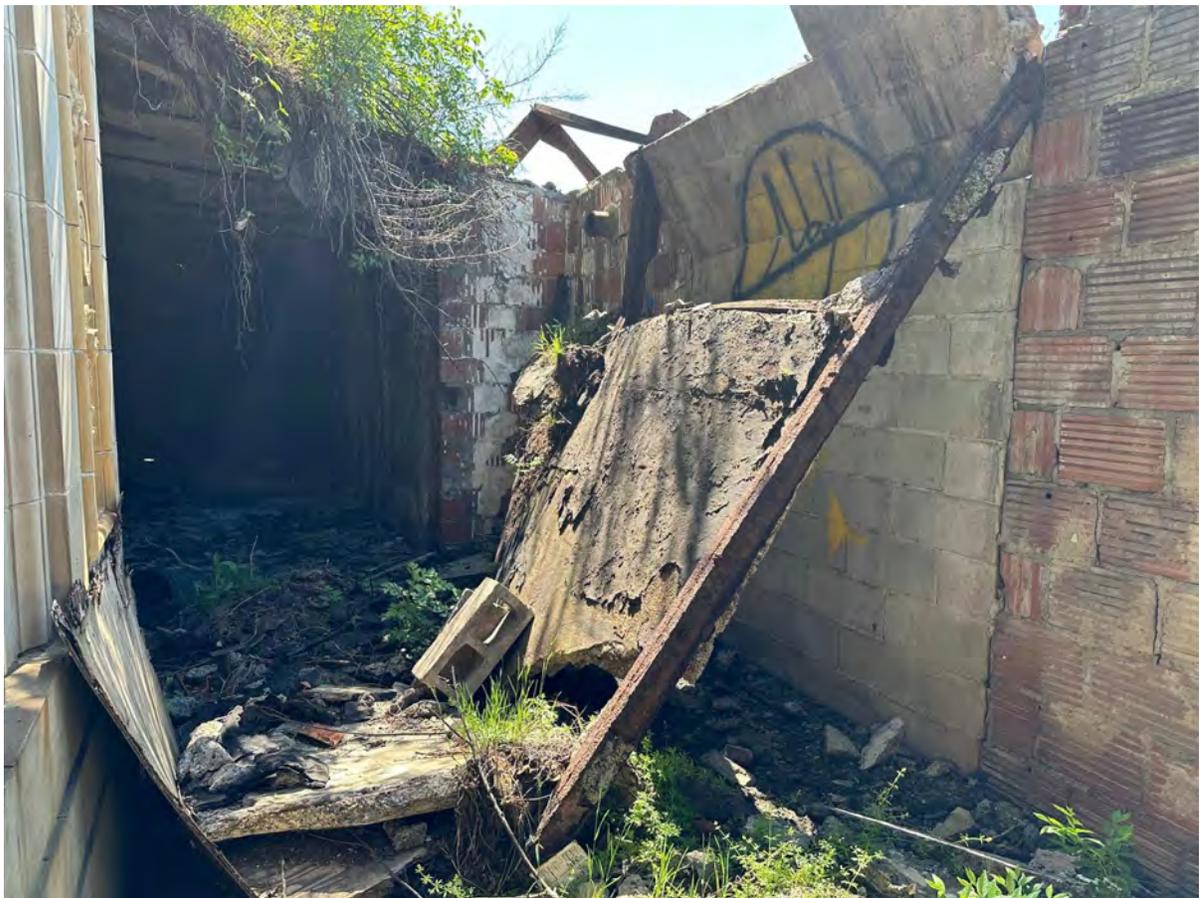
The south elevation originally consisted of a passageway leading to the stairs to platforms (since removed). This passageway was infilled at some unknown date. The ceiling/ roof constructed to originally cover this passageway has collapsed in certain areas. See Figures 07 and 08 for depictions of this area of the building (below).

*Figure 07 - Image of a portion of the roof and ceiling that has collapsed. This section of collapsed material is adjacent to the south elevation exterior wall. View looking east.*

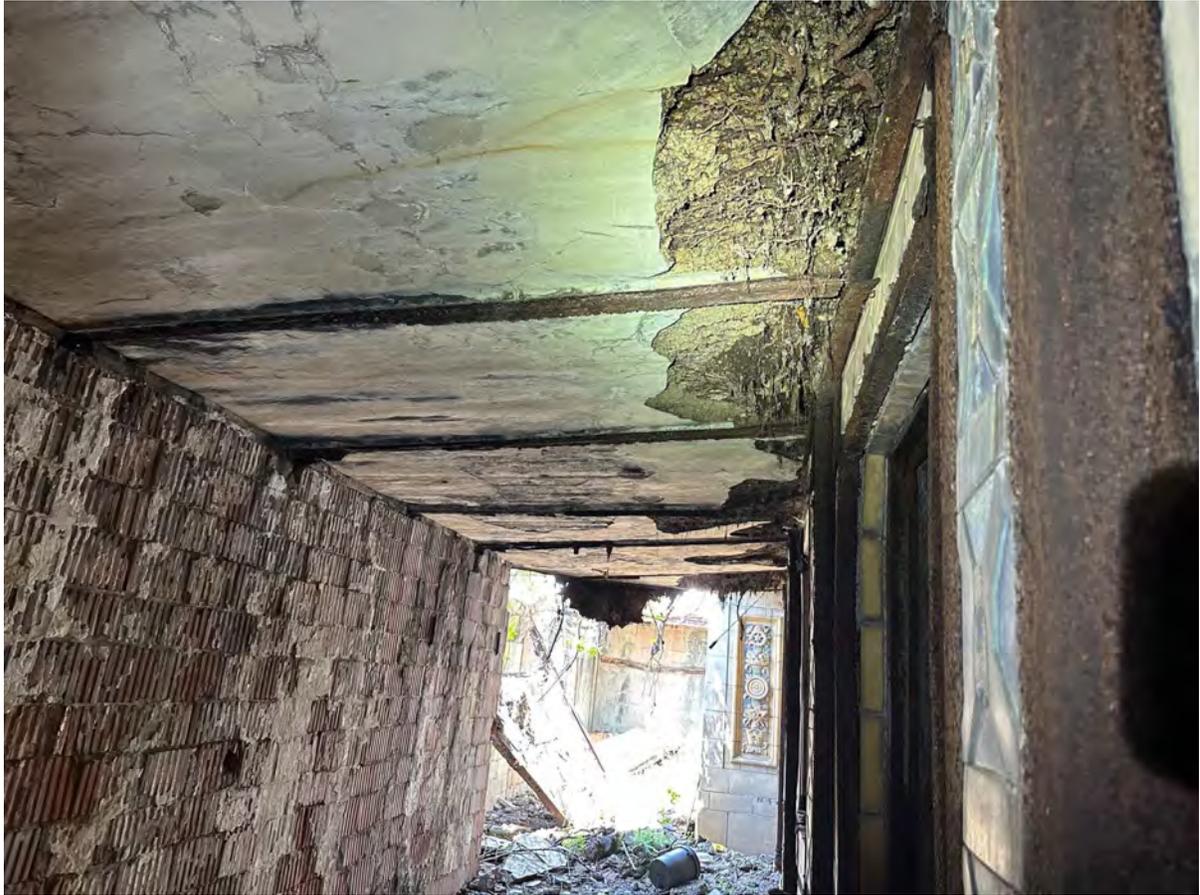
*Figure 08 - Image of a portion of the roof and ceiling that has not collapsed. This section of is adjacent to the south elevation exterior wall. View looking west.*

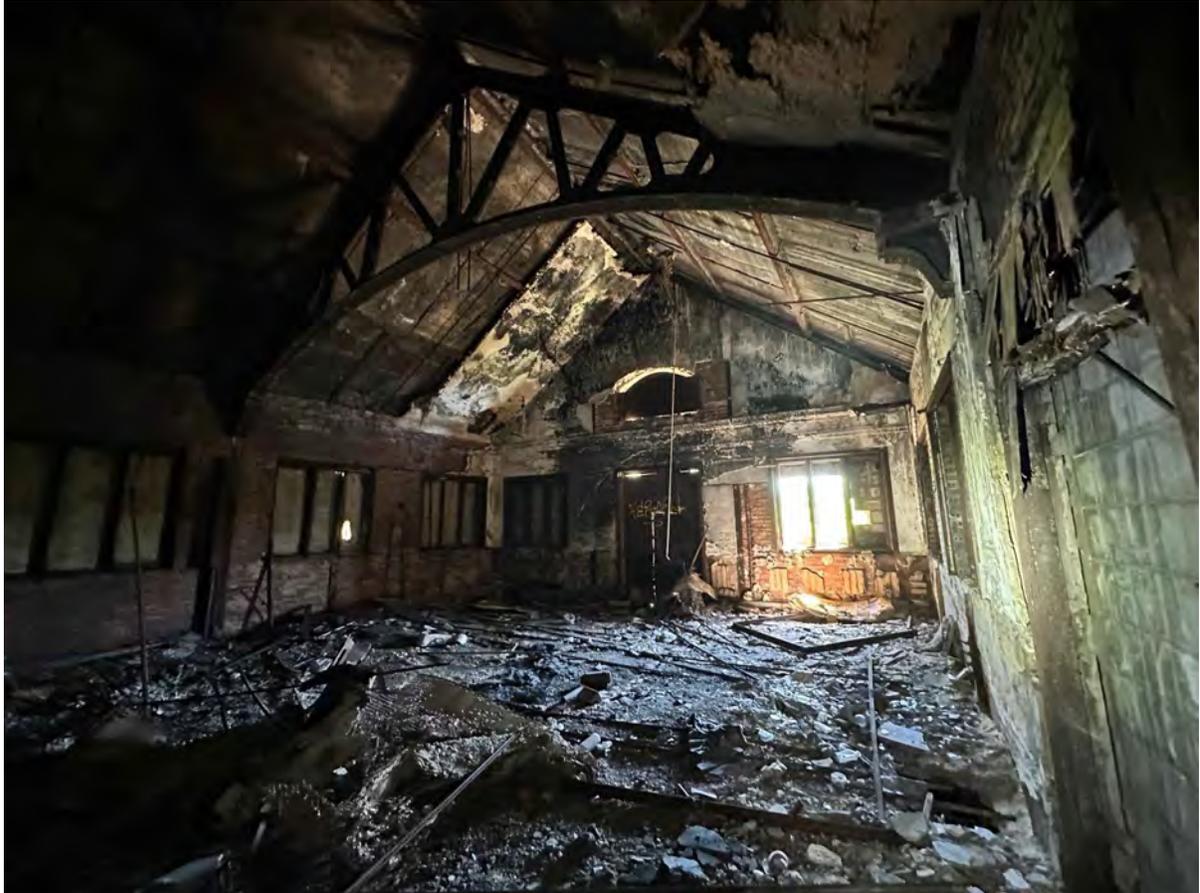
The former main waiting room (which extends eastward from the “head house”) consists of a steel framed building with reinforced concrete floor slabs, concrete roof slabs, and masonry infill exterior walls. In general, these structural steel elements appear to be in fair to good condition (especially the north/ south oriented frames that create each bay of the building).

*Figure 09 - Image of a portion of the interior of the former waiting room of the station. Note that the ceiling that has almost completely fallen down and the structural steel frame is now partially visible. This view is looking east towards the east exterior wall.*

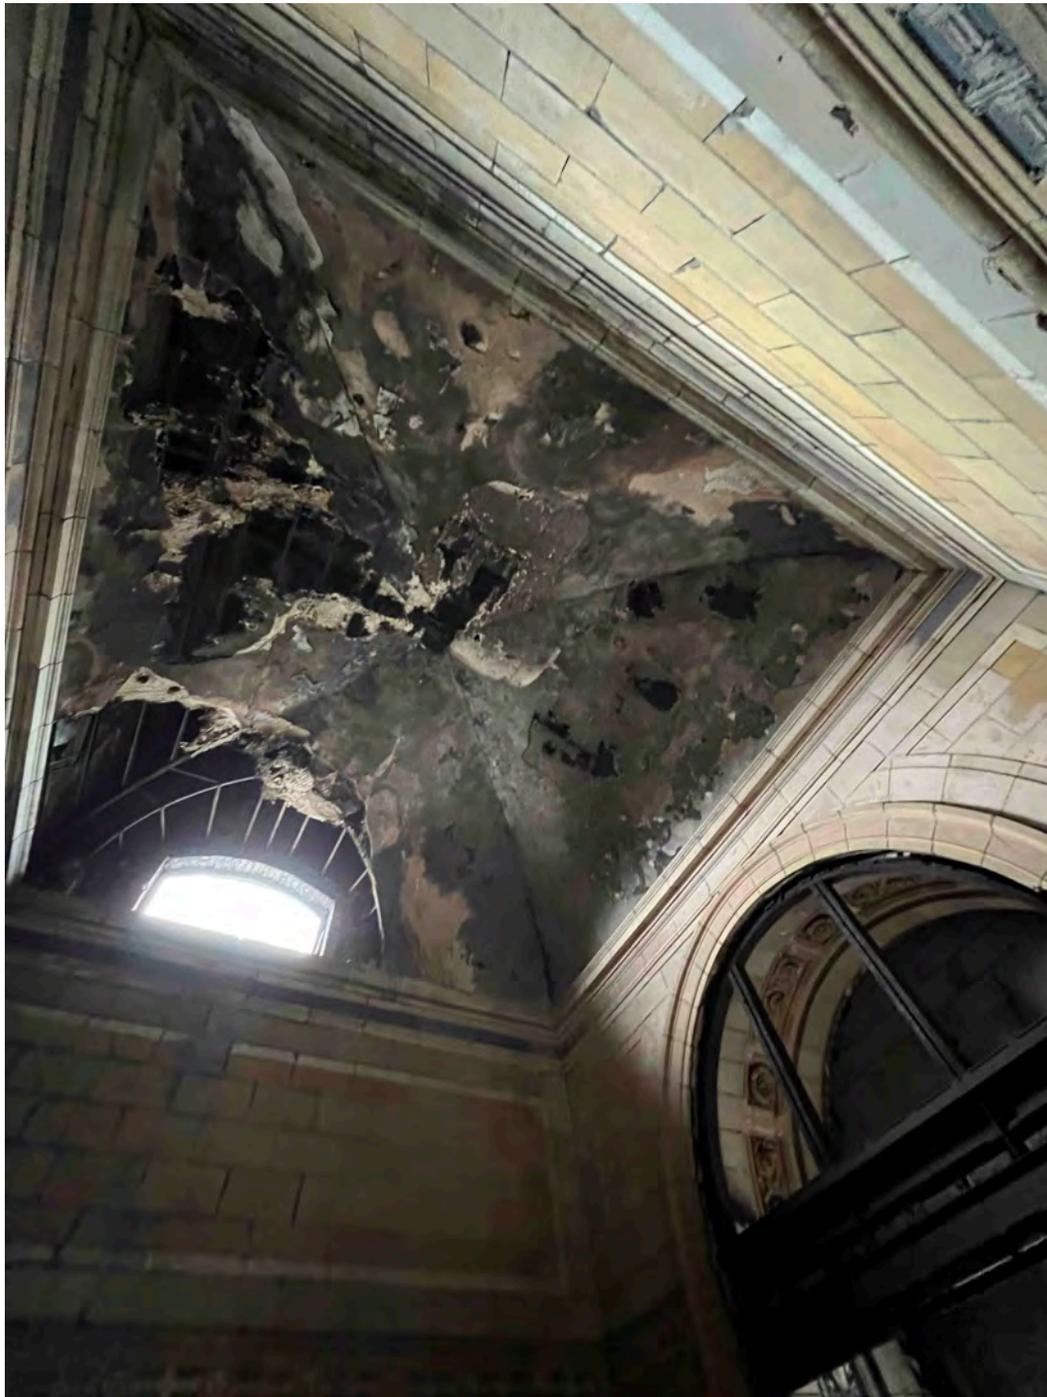
*Figure 10 – Image of the ceiling of the main room of the Head House. While the ceiling has localized areas of plaster failure, there is evidence that the steel framing above this ceiling is salvageable.*

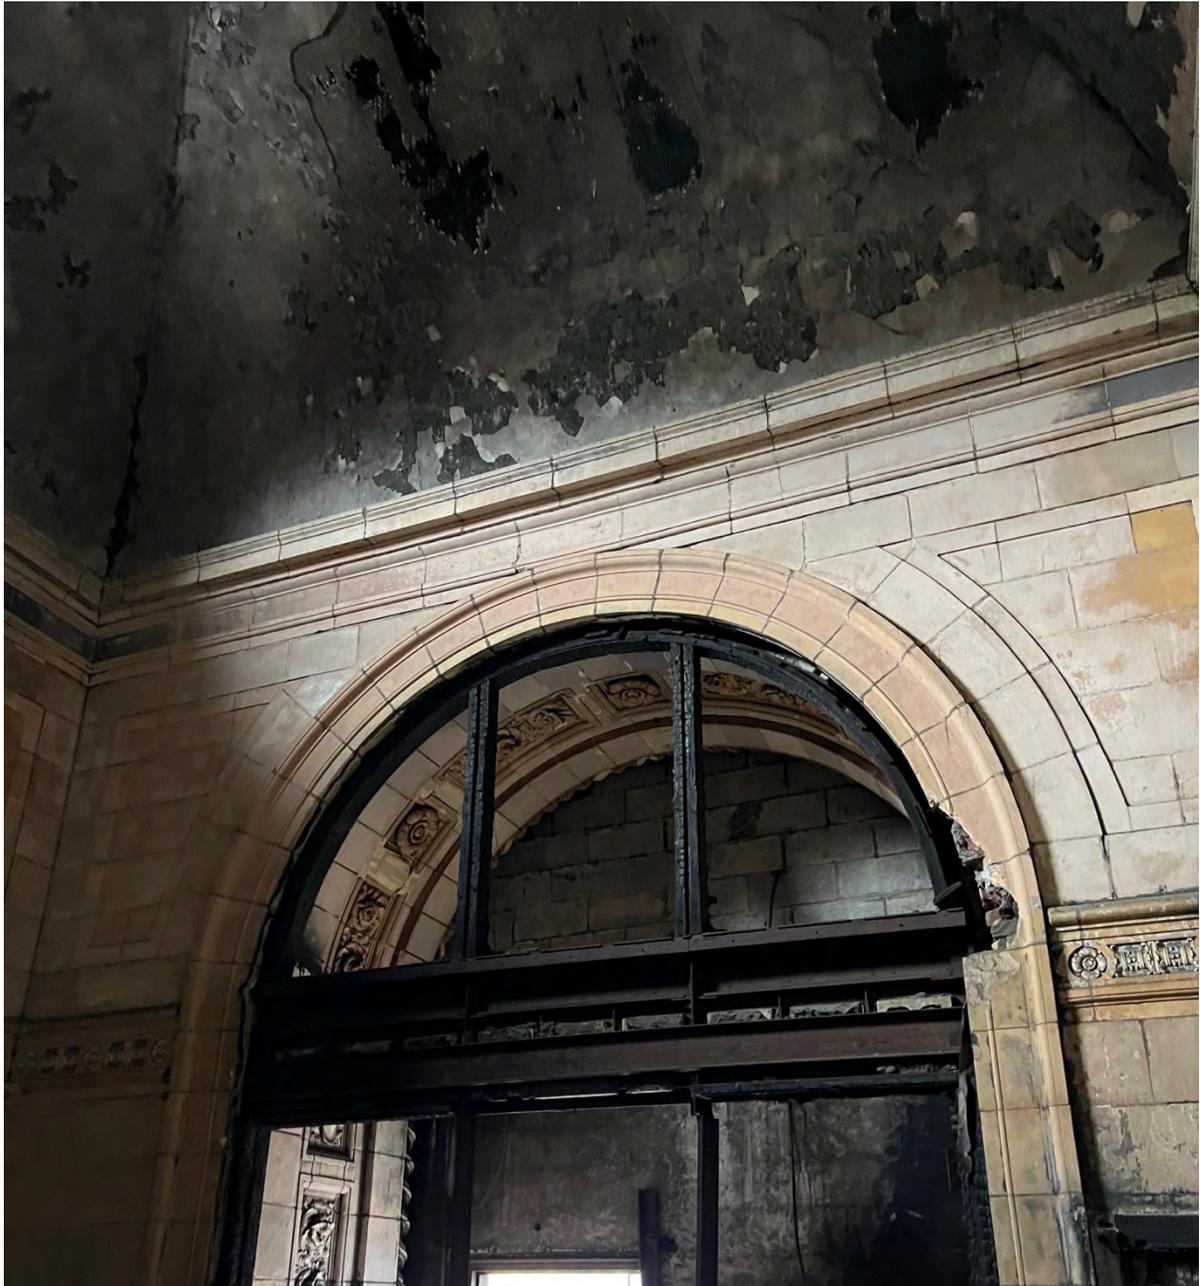
*Figure 11 – Image of some of the walls and the lower north side of the ceiling of the main room of the Head House. Note that much of the interior terra cotta wall surfaces appear to be in good condition indicating there's a good chance that the backup masonry walls could also be in good condition and salvageable as part of a plan of renovation/ re-use of the building.*

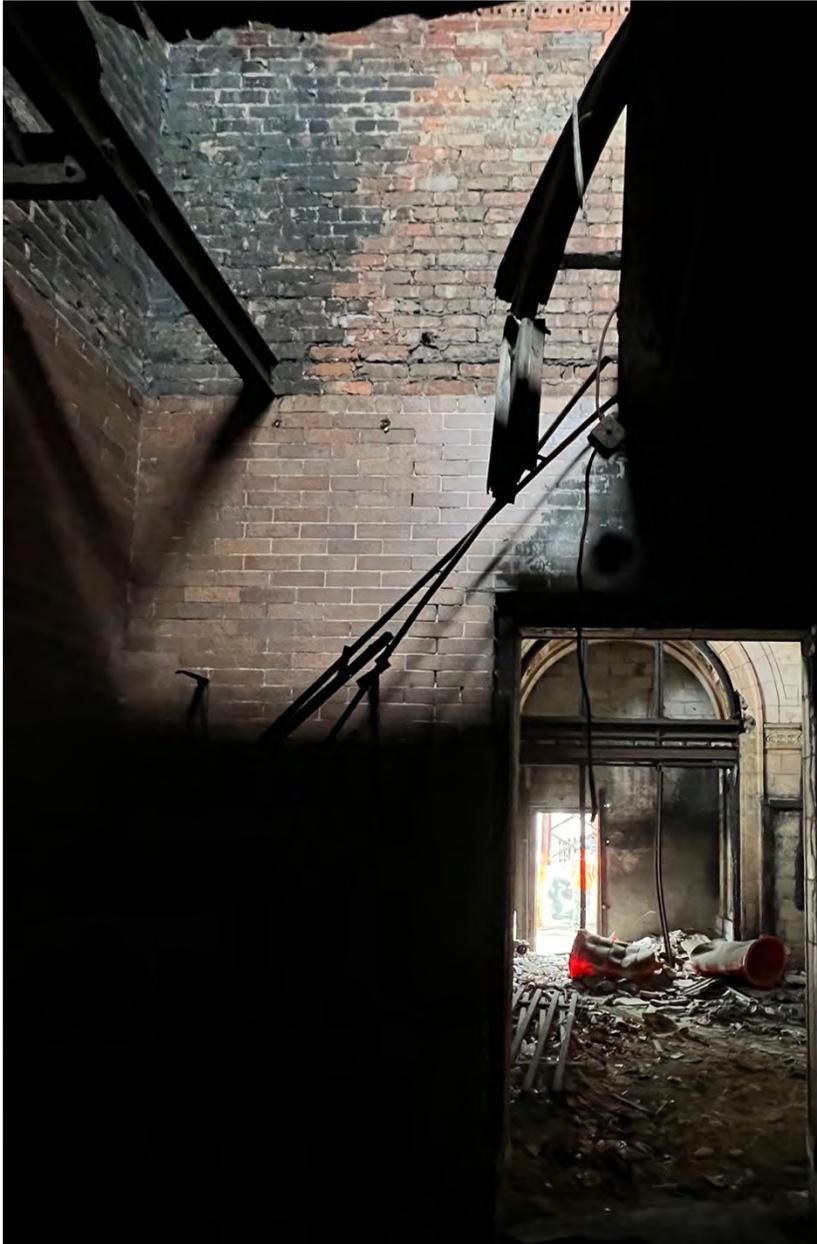
*Figure 12 – Image of one of the brick masonry walls within the Head House. While the intermediate floors/ stair landings above the main floor level are no longer intact, the masonry walls appear to be in good shape and capable of re-use.*

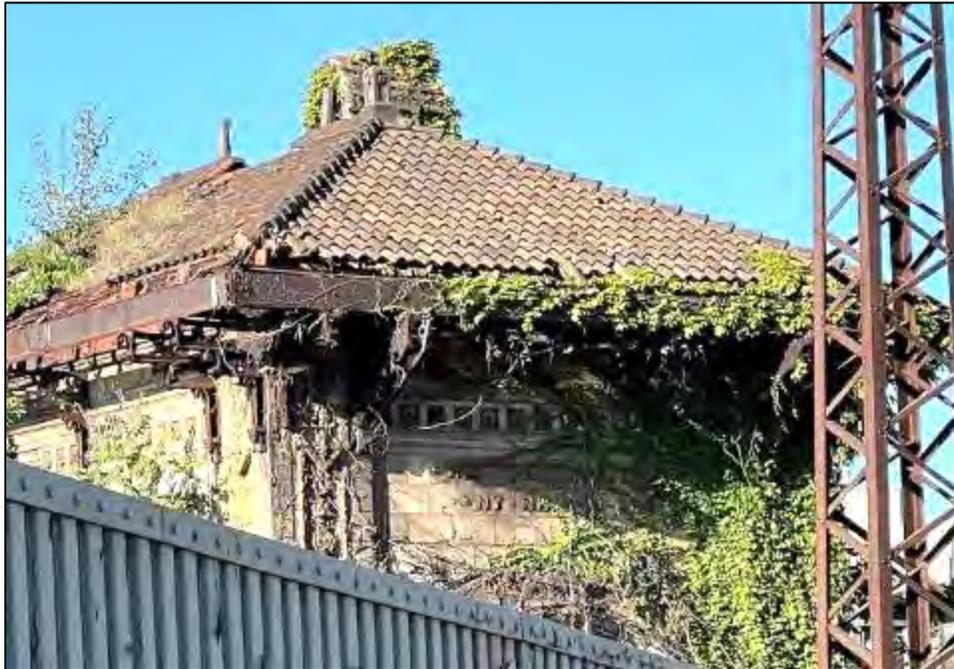
Figure 17: Heavy biological growth and vegetation are present on all the facades of the entry tower. Note the metal soffit is in poor condition. *Photographic source: JBC, 2024*

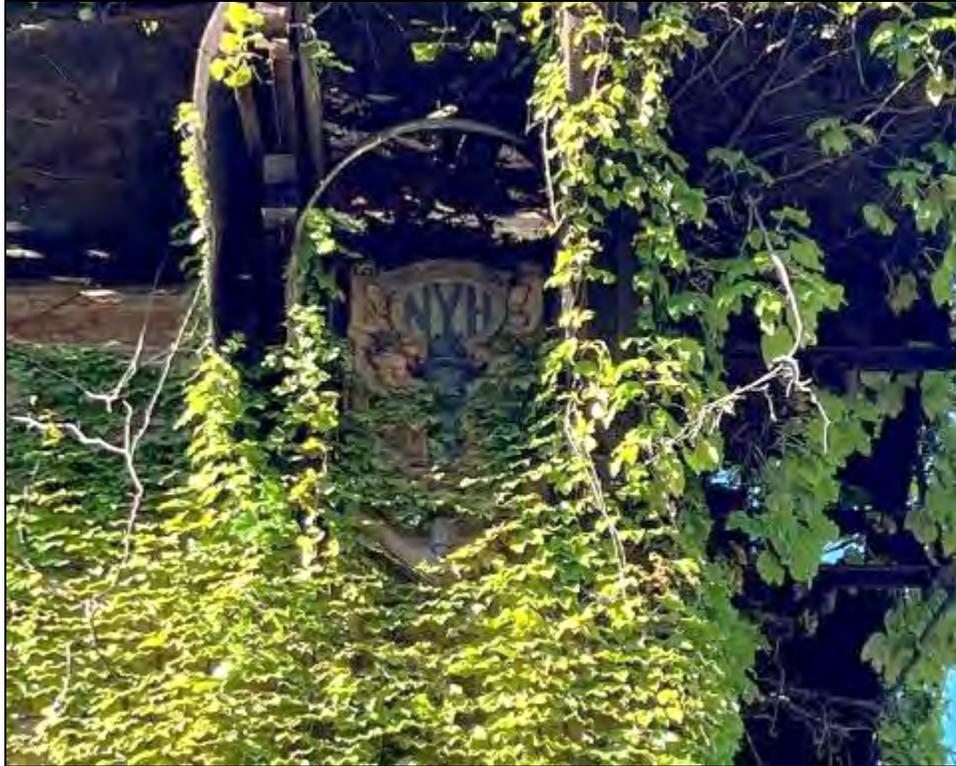
**Figure 18:** Heavy vegetation obscures much of all the facades of the entry tower. *Photographic source: JBC, 2024*

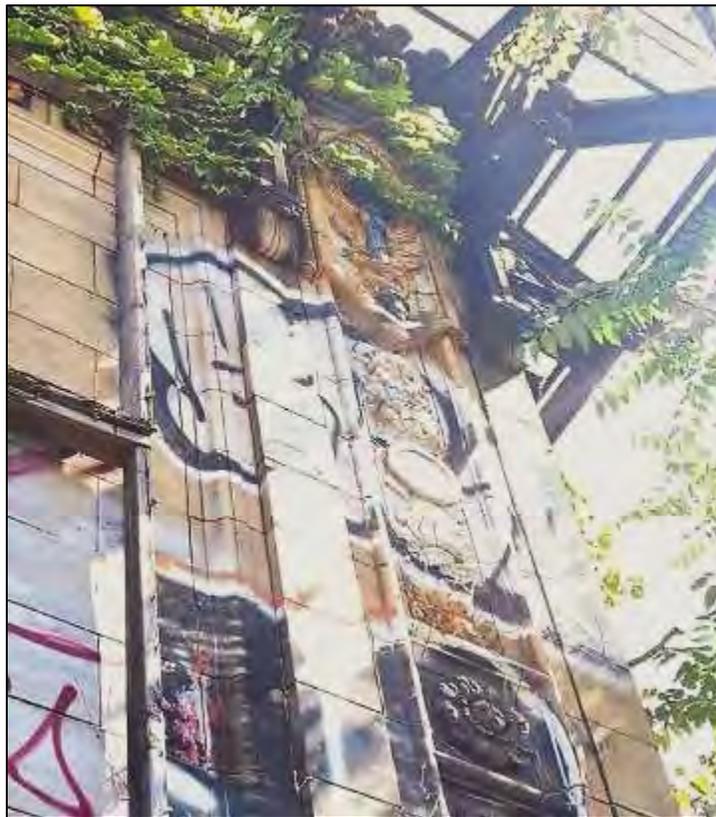
**Figure 19:** Paint and graffiti on the entry tower exterior. *Photographic source: JBC, 2024*

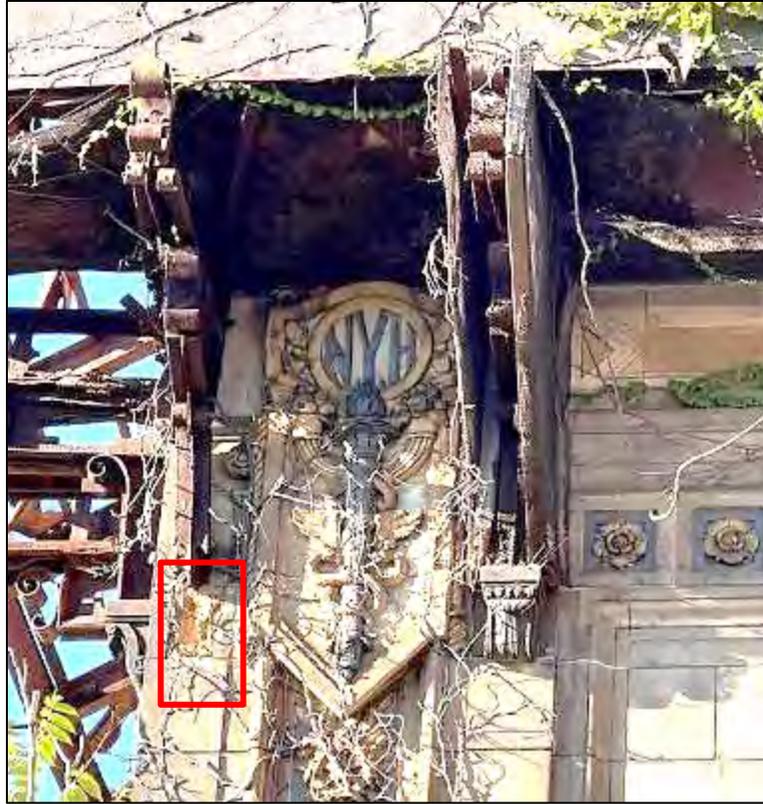
Figure 20: Spalled terra cotta at the top east corner of the north façade. *Photographic source: JBC, 2024*

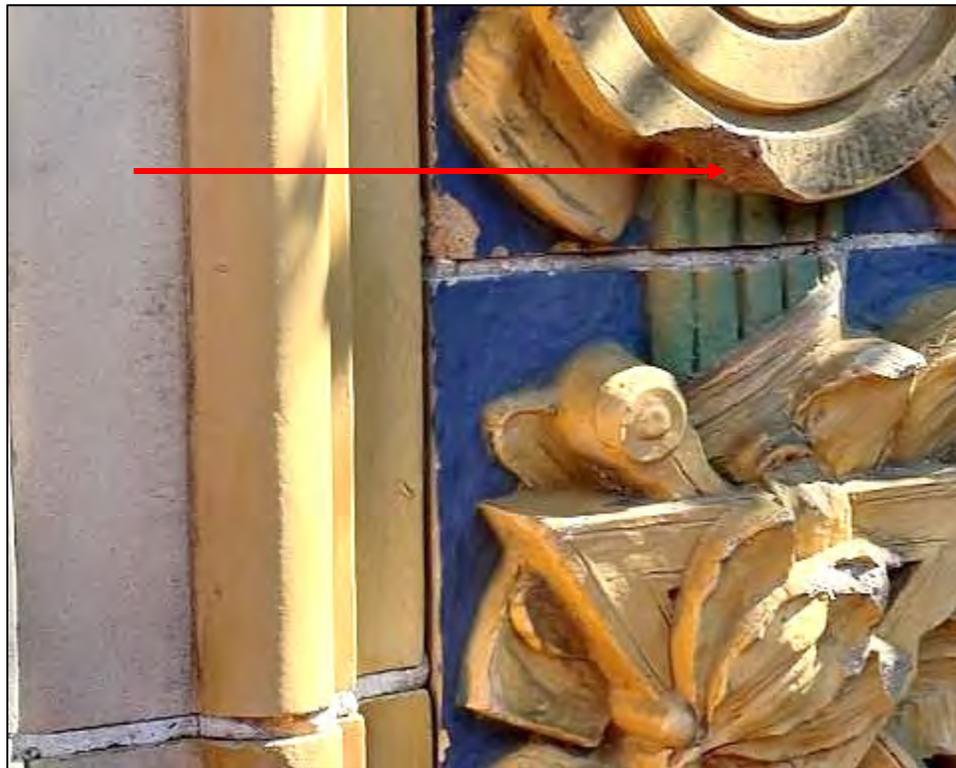
Figure 21: Chipped edges (arrow) and surface spalls of the decorative terra cotta. This is on the south façade. *Photographic source: JBC, 2024*

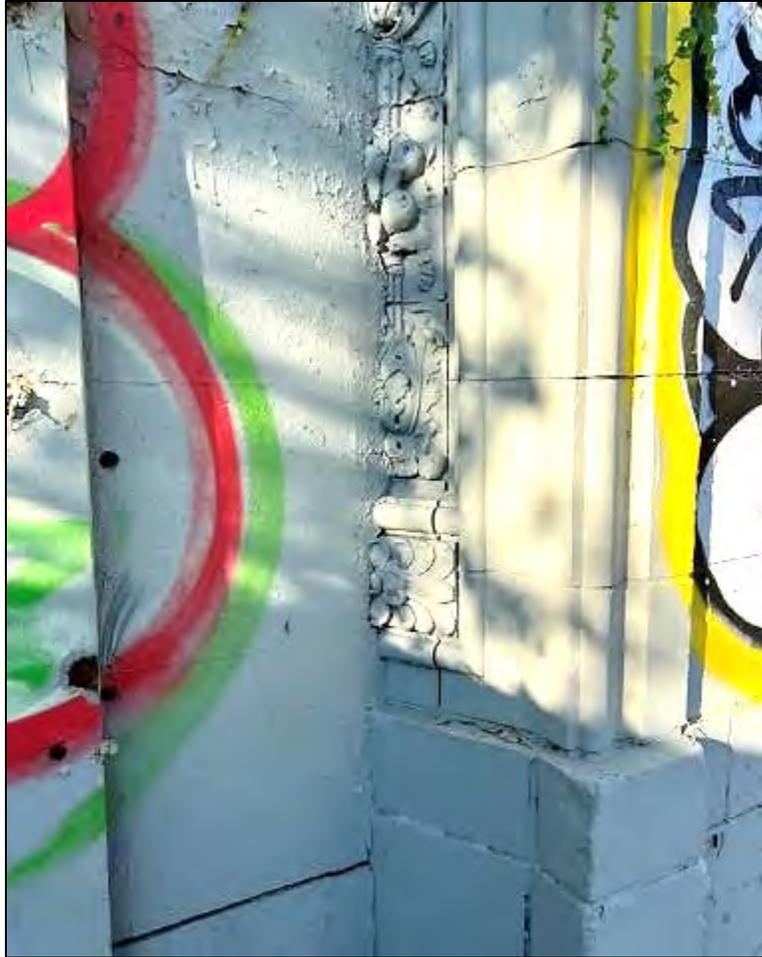
Figure 22: The CMU infill abuts the decorative terra cotta in the main entrance pier. Note the paint and graffiti on the exterior. *Photographic source: JBC, 2024*

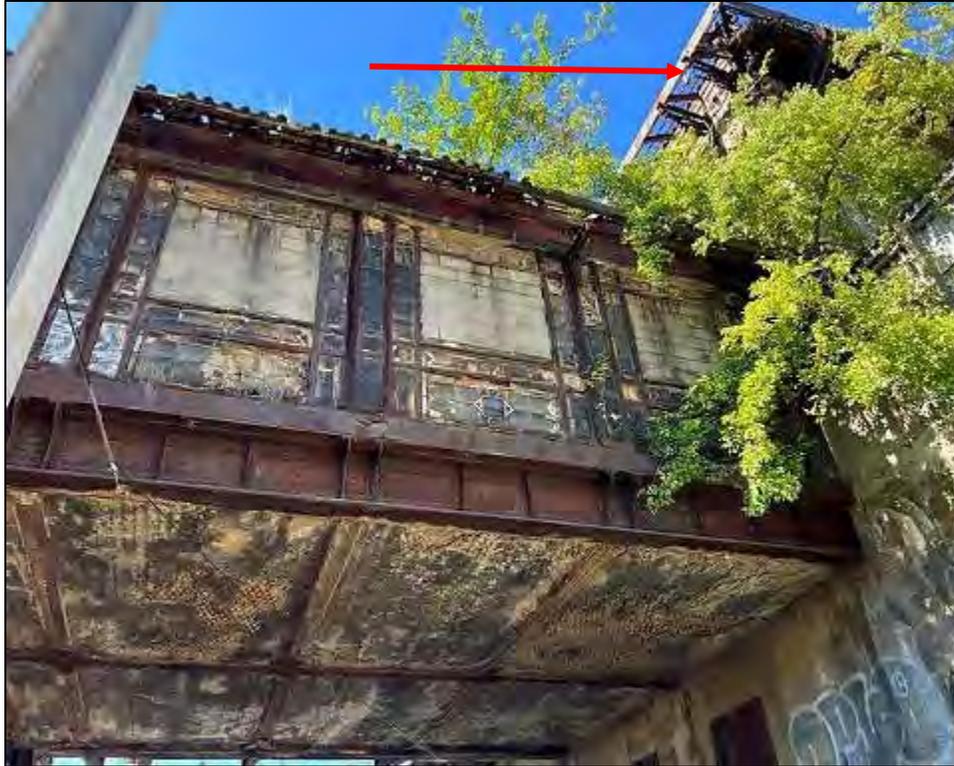
**Figure 23:** The metal soffit of the entry tower cornice is severely deteriorated and completely missing at multiple locations (arrow). A lot of the dark red Ludowici terra cotta roof tiles are missing. *Photographic source: JBC, 2024*

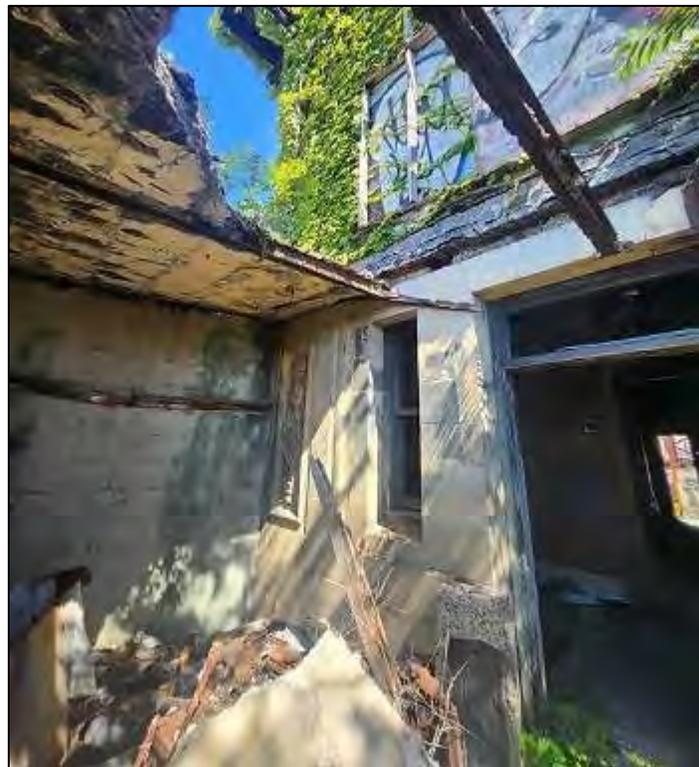
**Figure 24:** Partially collapsed roof on the west side of the south veranda. *Photographic source: JBC, 2024*

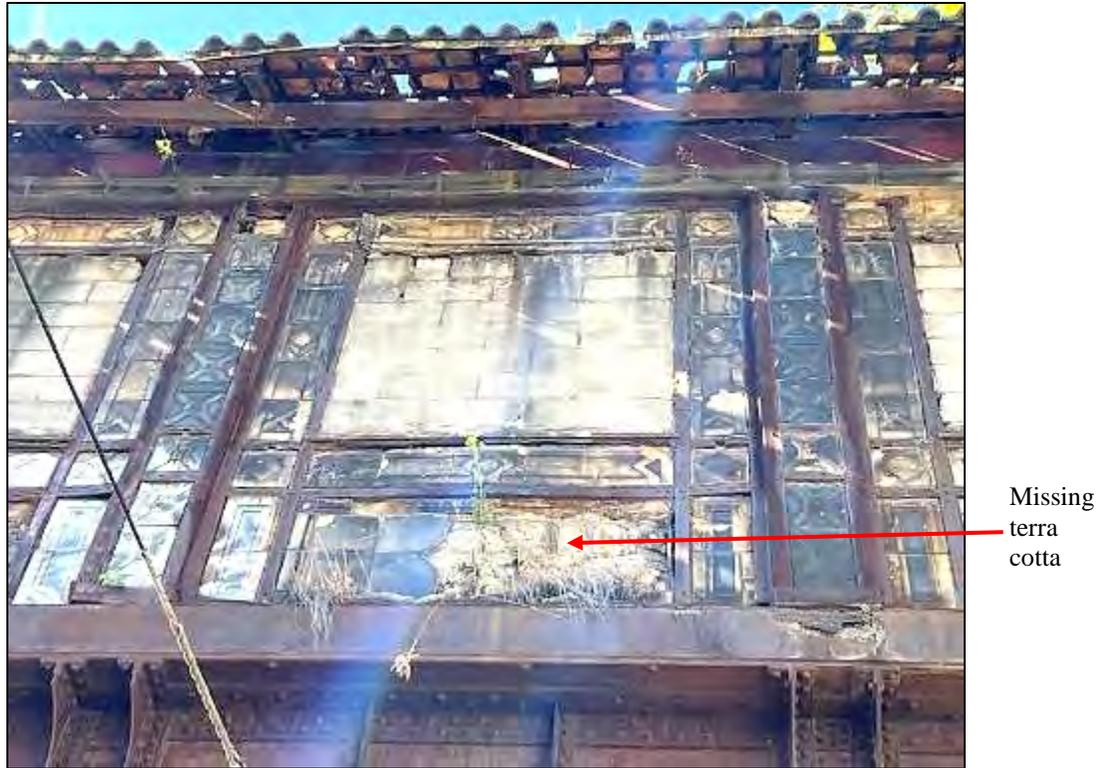
Figure 25: Exterior terra cotta on the north façade of the Station Main Block are loose and falling down onto the tracks because the metal holding them in place has corroded. *Photographic source: JBC, 2024*
