**Cass Gilbert's  
Westchester Avenue Station**  
Vacant structure of the Former New York New Haven and Hartford Railroad  
**Pre-schematic Conditions Assessment**

January 15, 2025  
Revised February 19, 2025

Prepared by:  
**SLO Architecture**  
**TYLin**  
**Jablonski Building Conservation**

**PRE-SCHEMATIC STRUCTURAL CONDITIONS ASSESSMENT**

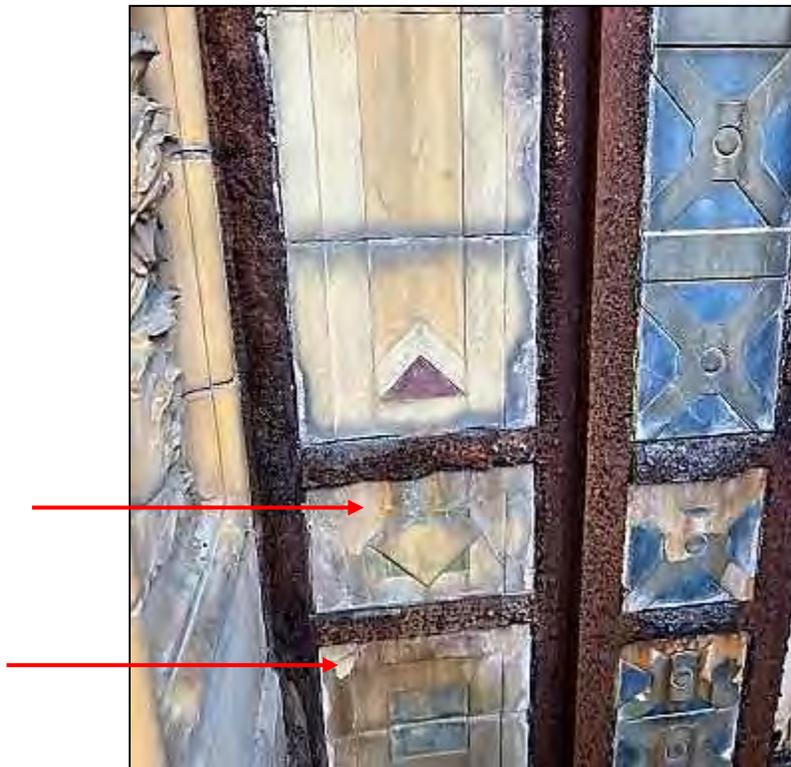
Figure 26: Surface spalls and chips along the edges of the exterior terra cotta on the south façade of the Station Main Block. Note the heavily corroding metal frame holding the terra cotta. *Photographic source: JBC, 2024*

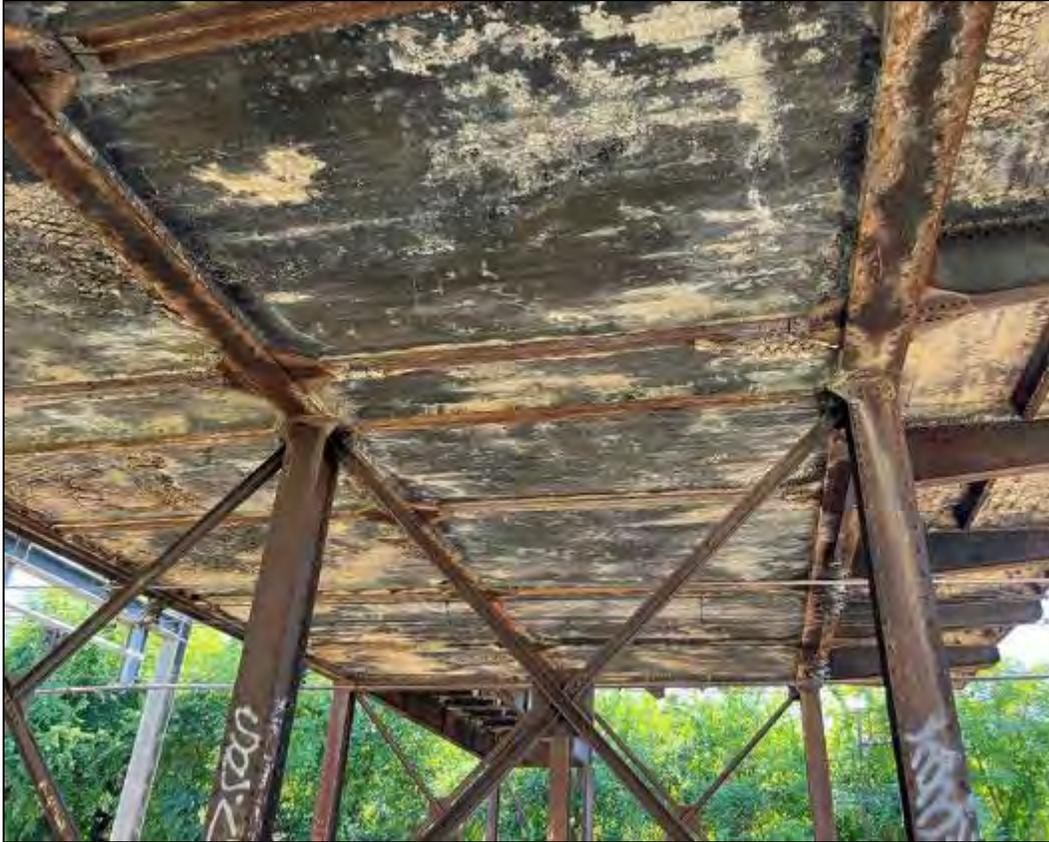
**Figure 27: Severely deteriorated and failing concrete stucco on the underside of the Station Main Block. Large amounts of concrete stucco is lost. *Photographic source: JBC, 2024***

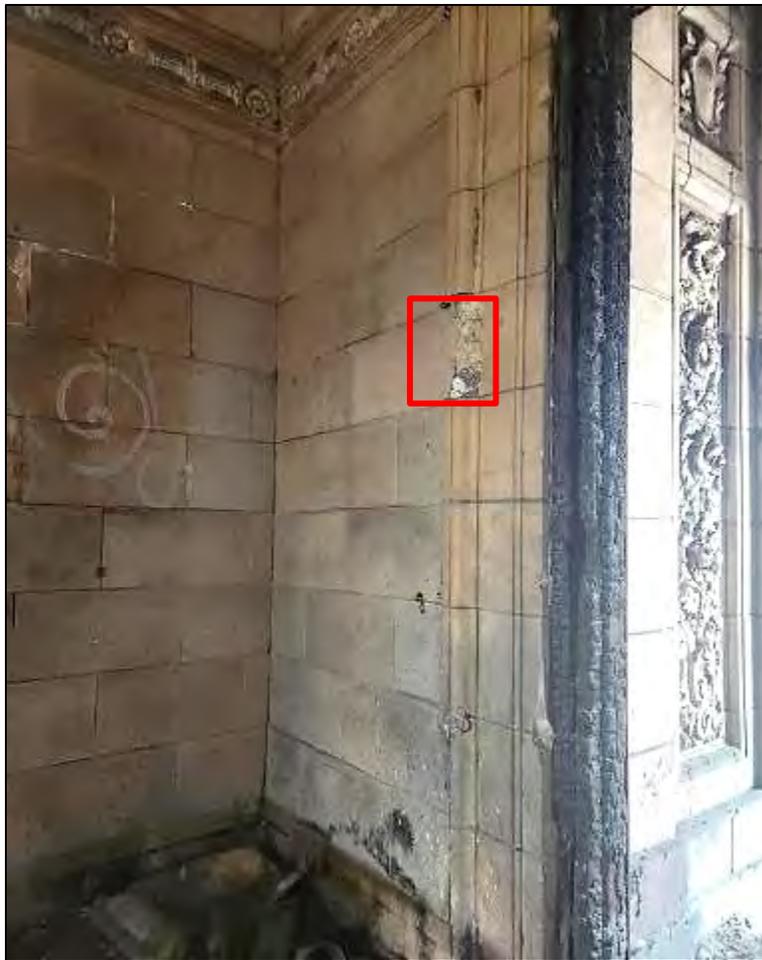
**Figure 28: Missing terra cotta unit from the door surround. Note the Graffiti on the adjacent wall.**  
*Photographic source: JBC, 2024*

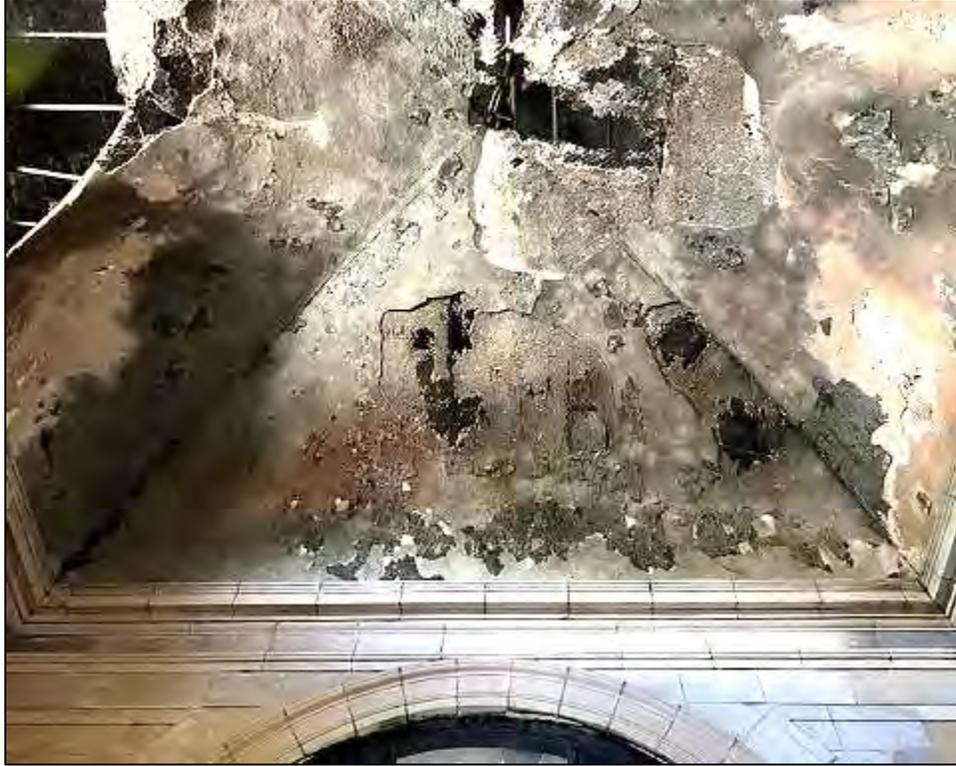
**Figure 29:** Loss of some roof deck in the headhouse has exposed structural steel frame. Much of the painted plaster has fallen off. *Photographic source: JBC, 2024*

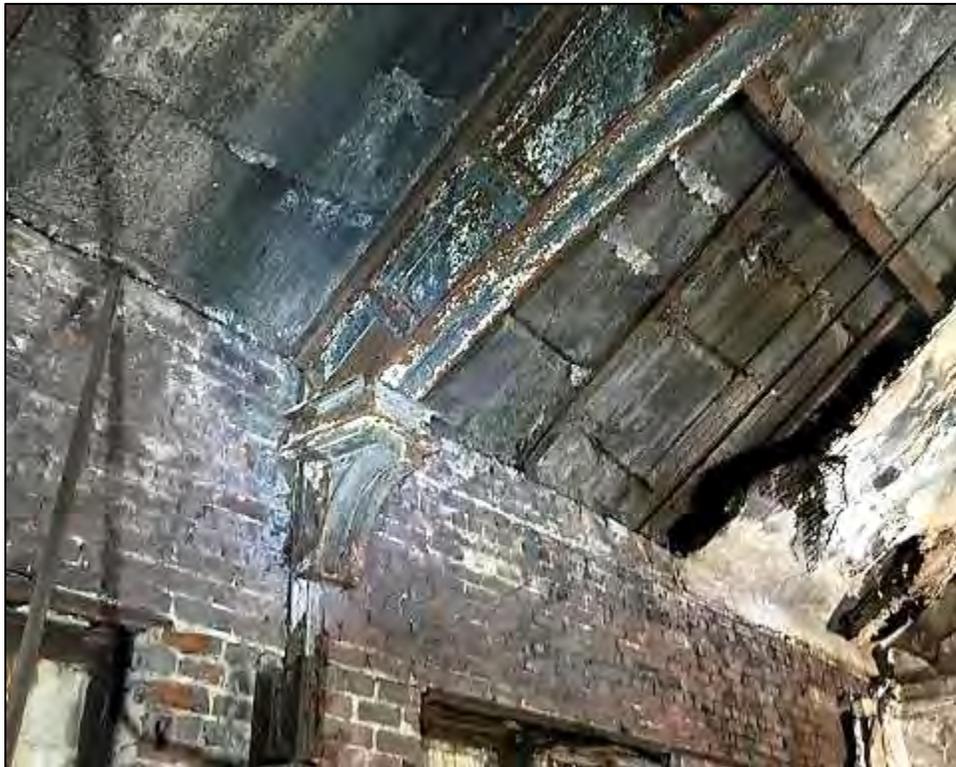
**Figure 30:** Underside of roof deck in the waiting room. Much of the painted plaster has fallen off. *Photographic source: JBC, 2024*

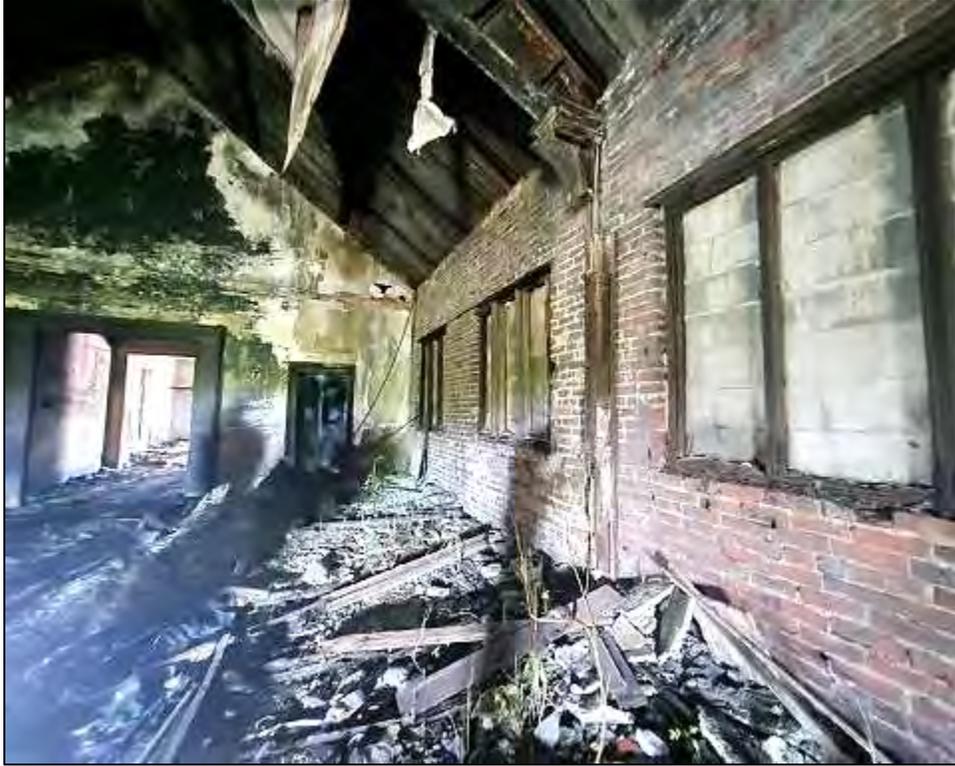
**Figure 31: Extensive debris on the floor of the station interior presents safety and accessibility issues.**  
*Photographic source: JBC, 2024*

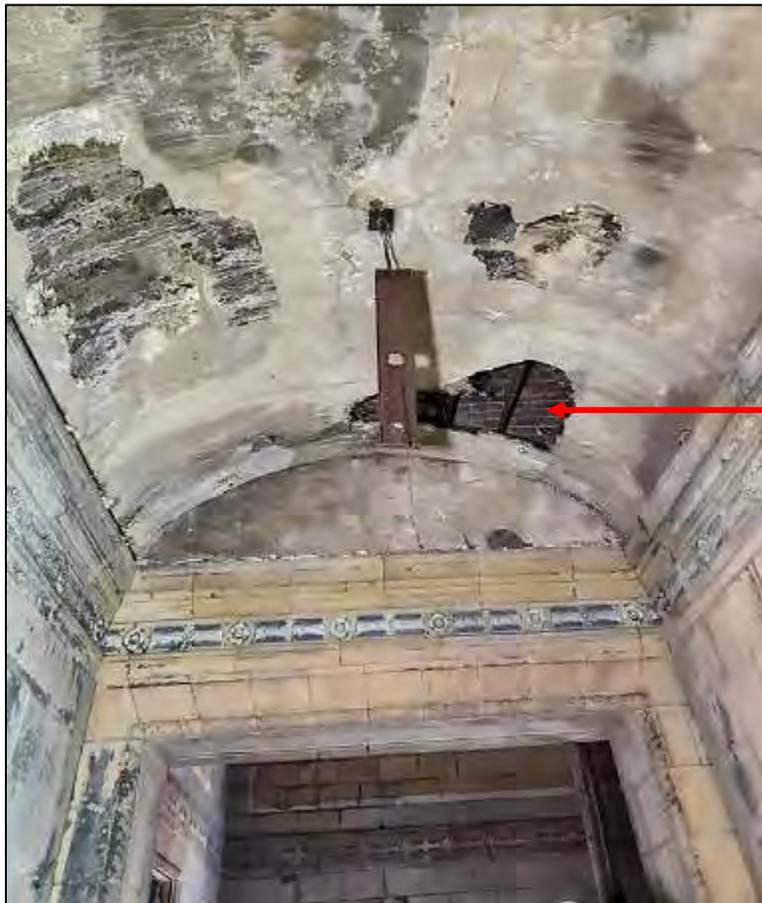
**Figure 34: Failing plaster ceiling in the hallway. The arrow shows missing plaster and roof deck. The decorative terra cotta are in fair condition. *Photographic source: JBC, 2024***

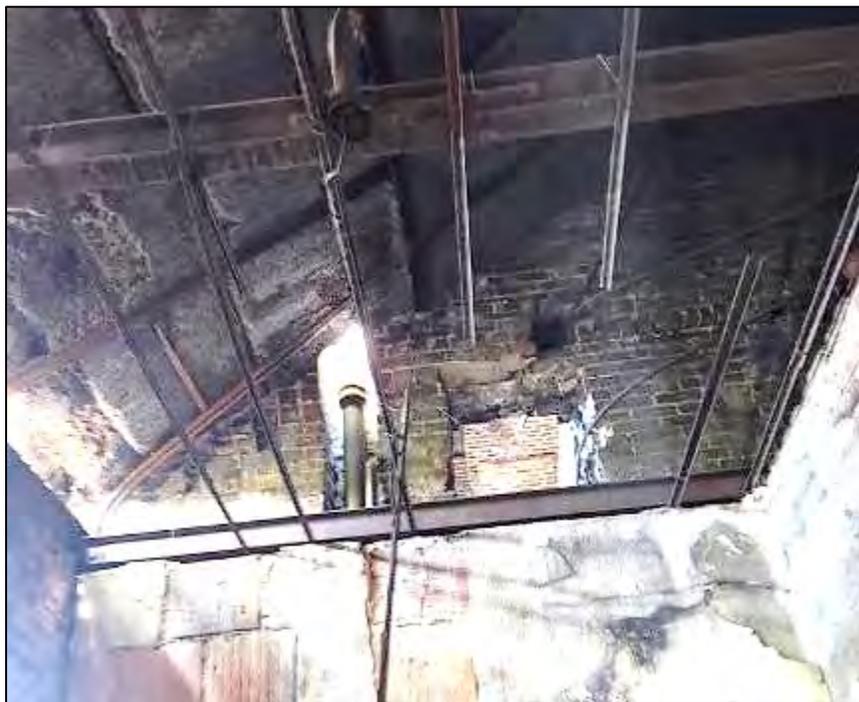
**Figure 36: Exposed structural steel frame of the restroom ceiling. *Photographic source: JBC, 2024***
