**Cass Gilbert's  
Westchester Avenue Station**  
Vacant structure of the Former New York New Haven and Hartford Railroad  
**Pre-schematic Conditions Assessment**

January 15, 2025  
Revised February 19, 2025

Prepared by:  
**SLO Architecture**  
**TYLin**  
**Jablonski Building Conservation**

**PRE-SCHEMATIC STRUCTURAL CONDITIONS ASSESSMENT**

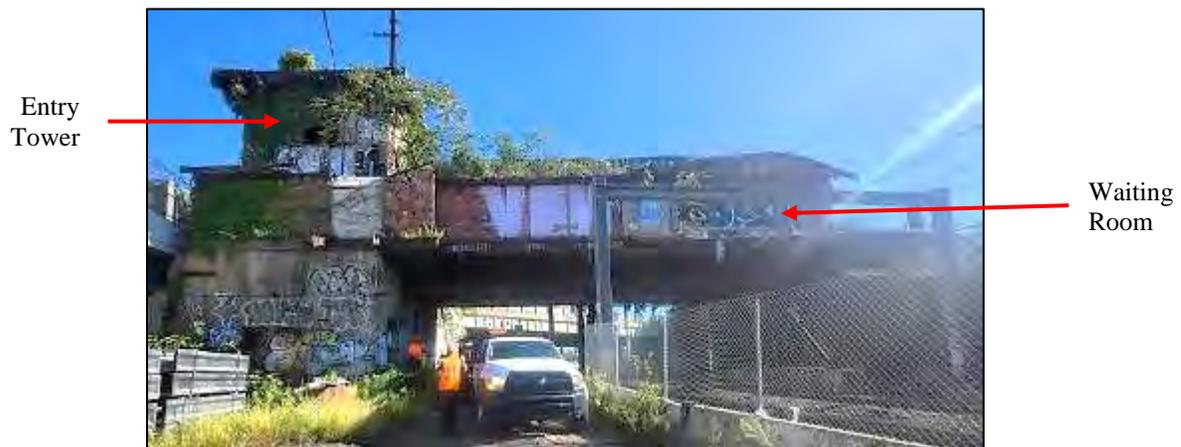
**Figure 2: Looking at the south elevation of Westchester Avenue Station from the track level.**  
*Photographic source: JBC, 2024*

All the window openings in the waiting area have CMU infill. No original window frames and sashes are present. The semi-arched window opening at the gable end on the east façade is partially infilled with brick and covered with sheet metal. The covered south veranda, which originally led passengers to the stairs to the platforms, has been blocked with CMU wall sections that have paint and graffiti, and some vegetation on the outside (refer to Figure 2).

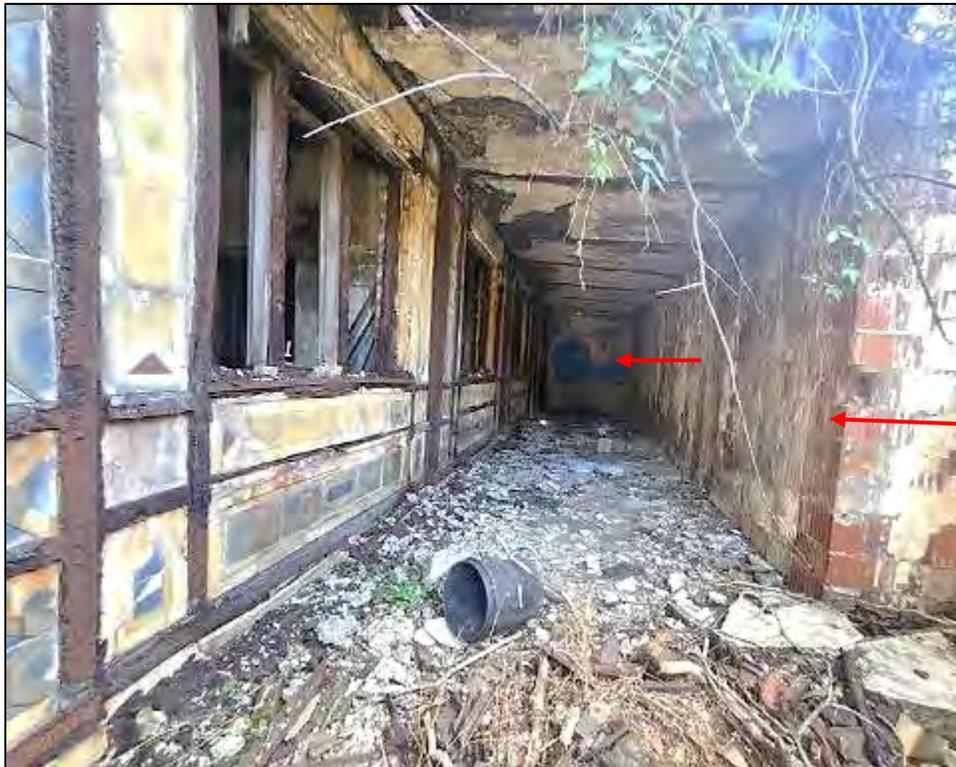
Figure 10: Northeast view of the south façade of the main block and covered south veranda (arrows show original openings now infilled). *Photographic Source: JBC*

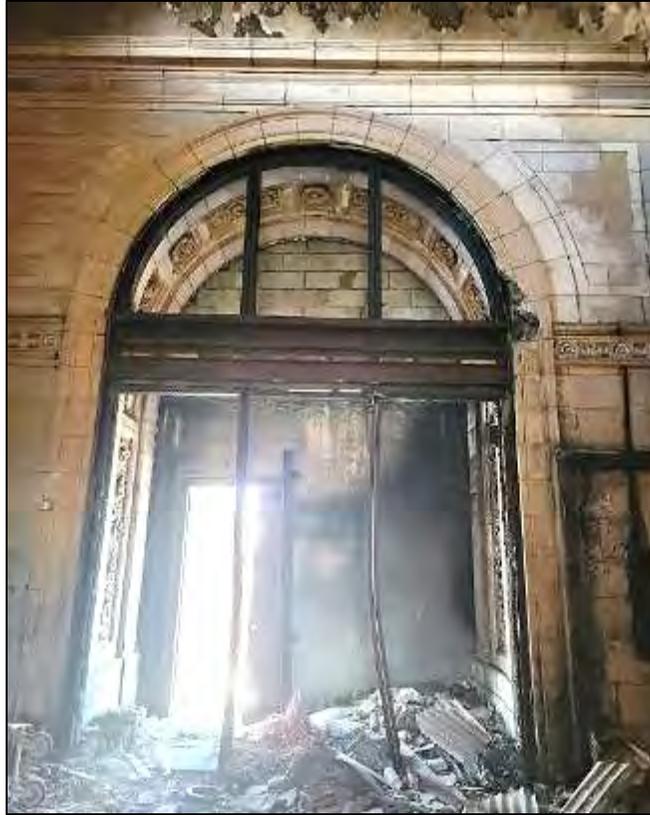
Figure 11: The main arched entrance has a tripartite door and a transom. Only the frames exist now.  
*Photographic source: JBC, 2024*

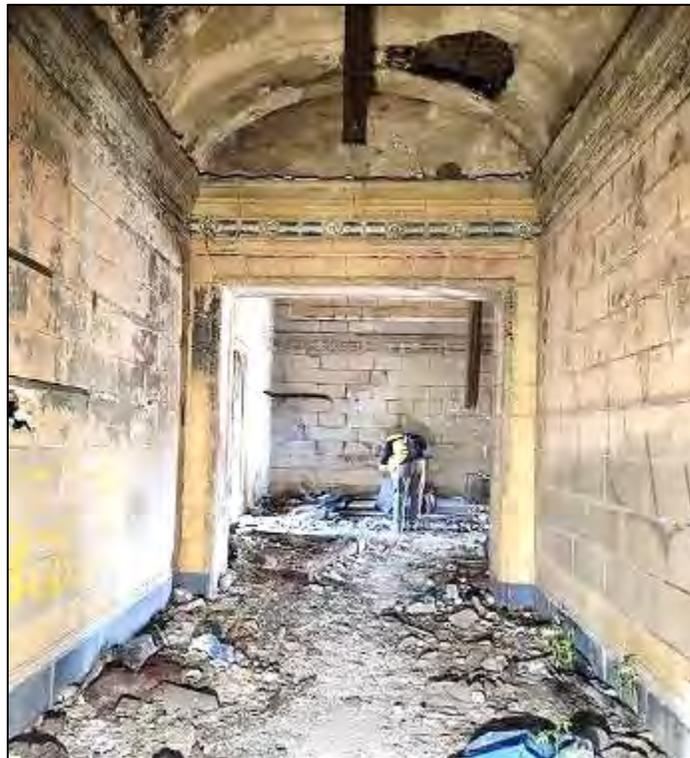
**Figure 14: Vaulted passageway connecting the entry tower to the waiting area. It has decorative terra cotta band at the cornice level, and painted plaster on the ceiling. *Photographic source: JBC, 2024***

The hallway connecting the waiting area and the headhouse is a vaulted space decorated with colored terra cotta at the cornice level and scrolls around the openings; all appear to be in fair condition with spalls and some missing units. The painted plaster in the ceiling is in poor condition with much of it lost and the remaining exhibiting cracks and paint loss (Figure 34).

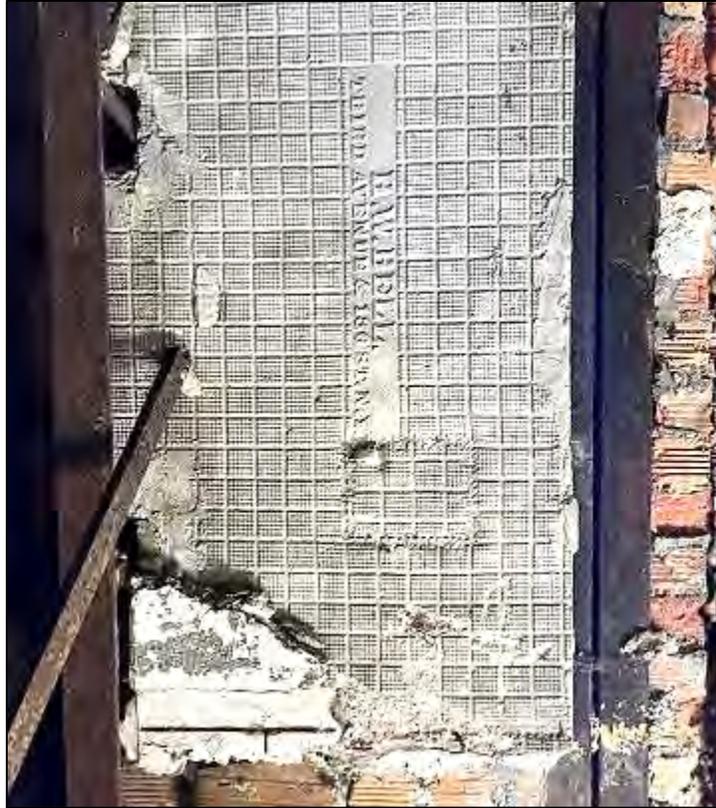
While much of the ceiling and wall plaster in the waiting room have collapsed and created extensive debris on the floor, the two exposed steel trusses holding the roof appear to be in fair condition. The damaged plaster found on the wall had a local manufacturing company name “H. W. Bell, Third Avenue & 136 St. N.Y.” stamped on the base coat (Figure 32). The waiting room has decorative painted plaster paneling and continuous band composed of geometric shapes (similar to the decorative colored terra cotta tiles on the exterior) at the cornice level that remains in few locations (Figure 33).

Figure 32: Manufacturing company name “H. W. Bell” stamped onto the plaster base block. This is on the east wall of the waiting room. *Photographic source: JBC, 2024*

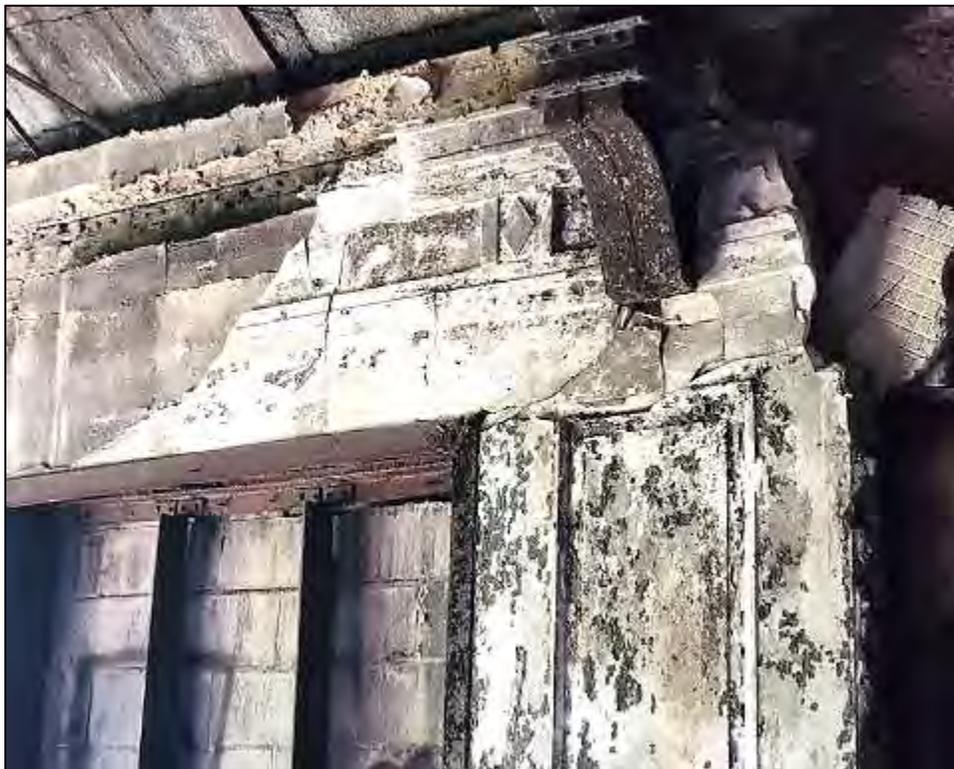
Figure 33: Decorative painted plaster paneling on the waiting room walls. *Photographic source: JBC, 2024*

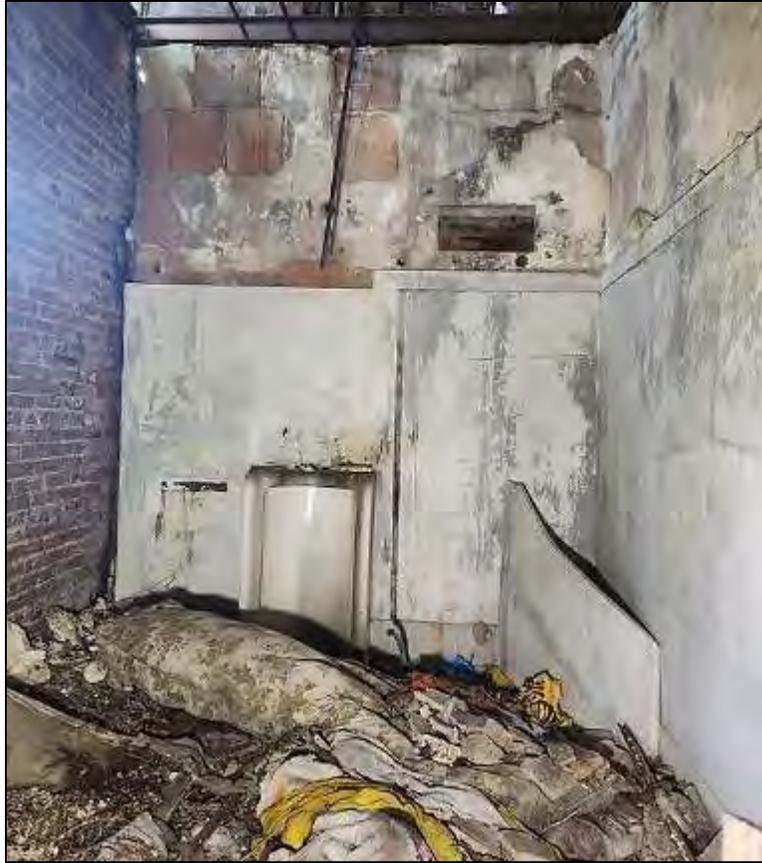
**Figure 35: Interior of the restroom with marble slabs. *Photographic source: JBC, 2024***
